High Performance & UV-Stable Coating for Leading Edge Protection

5721

Belzona 5721 is a 2-component, high-performance coating, specifically formulated for protecting the leading edge of wind turbine blades from erosion and impact damage.

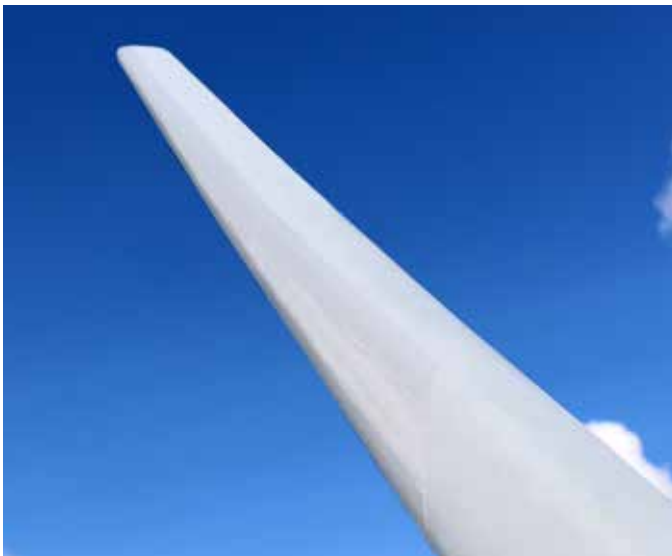
Belzona 5721 is available in two colours - White and Light Grey (RAL 7035)

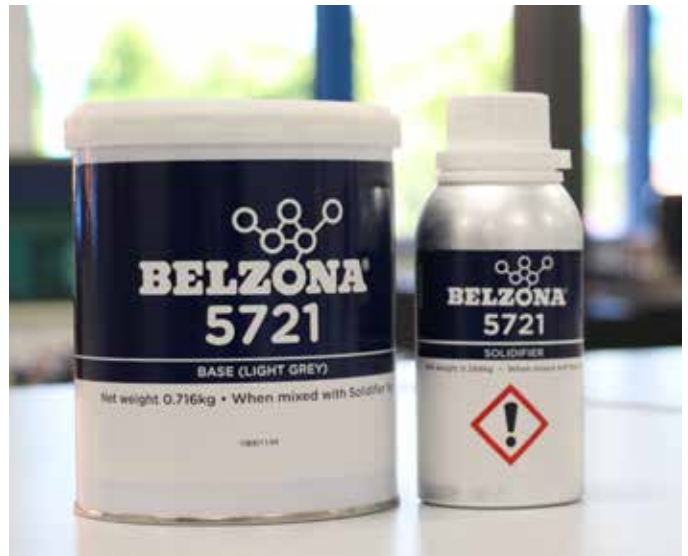
The unit size of Belzona 5721 is optimised for in-situ application
