# Multi-Purpose, High Temperature Repair and Rebuilding System

Belzona 1511 (Super HT-Metal) is a high temperature, paste-grade system for rebuilding equipment damaged by erosion-corrosion. This material can also be used as a high-strength structural adhesive or for the creation of irregular load bearing shims.

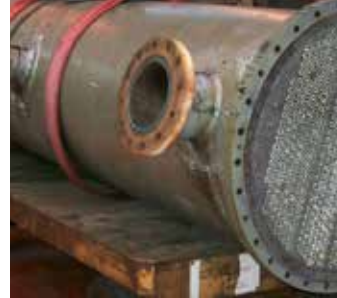
Heat exchanger tube face damaged by severe galvanic and pitting corrosion. Rebuilt with Belzona 1511 prior to the application of a Belzona high temperature coating.

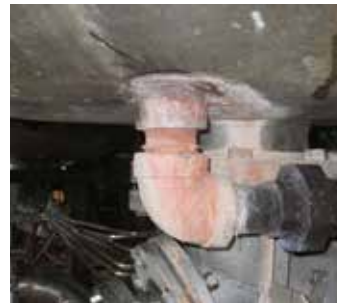
Process kettle developed holes in the weld seam as a result of corrosion. Belzona 1511 used to repair holes for the long term.

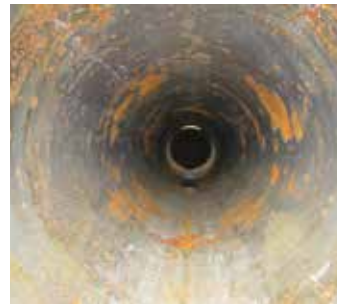
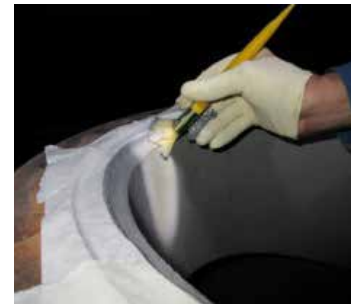
High temperature vessel suffering from severe corrosion. Pitted surface rebuilt using with Belzona 1511.
