Belzona 5871

FN10198

INSTRUCTIONS FOR USE

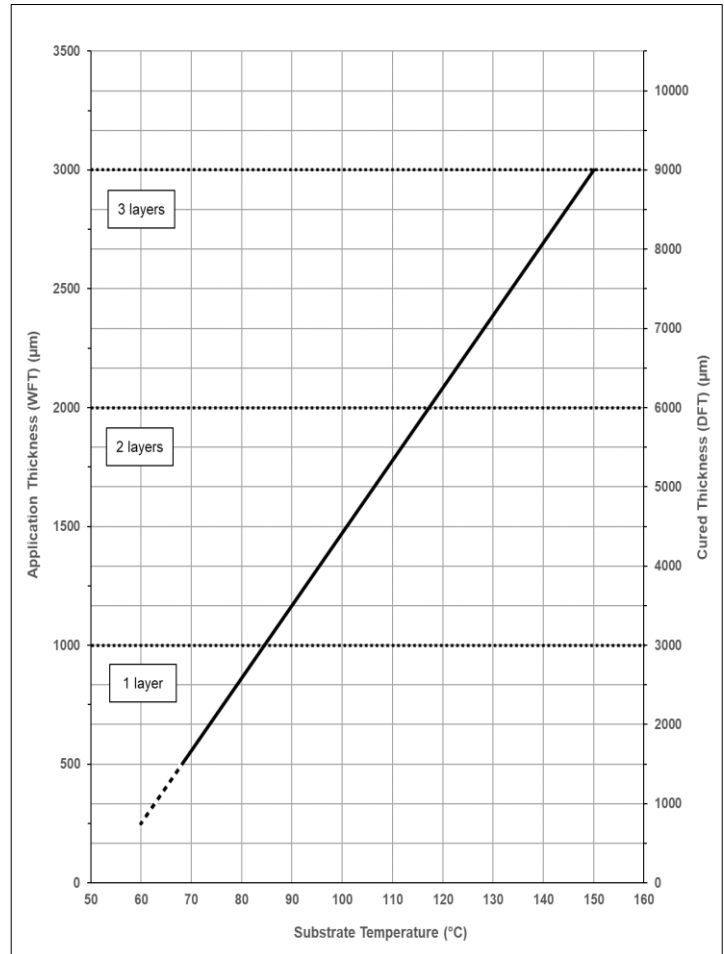
4.4 FILM THICKNESS REQUIRED TO REDUCE SURFACE TEMPERATURE TO ≤ 60°C BASED ON SUBSTRATE TEMPERATURE

- Apply the first layer of **Belzona® 5871** at the recommended film thickness based on coverage rate. See Section 4.4 for recommended film thickness based on surface temperature reduction requirements.
- As soon as possible after application of the first layer, apply a further layer of **Belzona® 5871** as in (a) above. This time will be typically 6 hours at 20°C (68°F). Overcoating must occur within 24 hours, irrespective of temperature. After this time the surface must be abraded to produce a frosted appearance, free of any gloss, with a target profile of 25 microns.
- If required, apply a third layer of **Belzona® 5871** as in (b) above.

Where service conditions permit, **Belzona® 5871** may be applied as a single layer. Apply **Belzona® 5871** at the recommended film thickness based on coverage rate. See Section 4.4 for recommended film thickness based on surface temperature reduction requirements.

NOTE – Minimum recommended thickness is 500 microns wet film thickness per layer.
